13 January 2014

RE: Rail Haulage Dust Audit – Duralie Coal Mine

This letter outlines the observations and findings of the audit conducted on 28 November 2013 and includes some recommendations to the current operations.

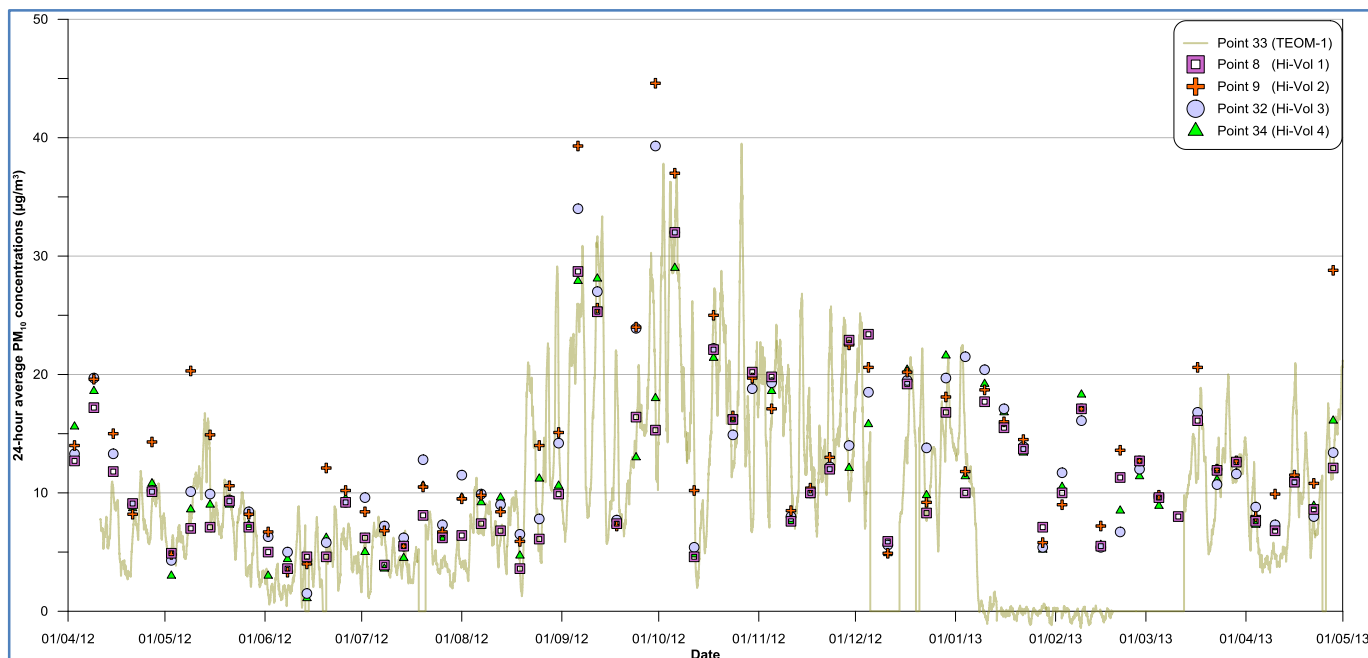
The recorded dust levels are below the key applicable criteria of 50 µg/m³ for 24-hour average PM₁₀.

Figure 1: Duralie TEOM and HVAS 24-hour average PM₁₀ levels

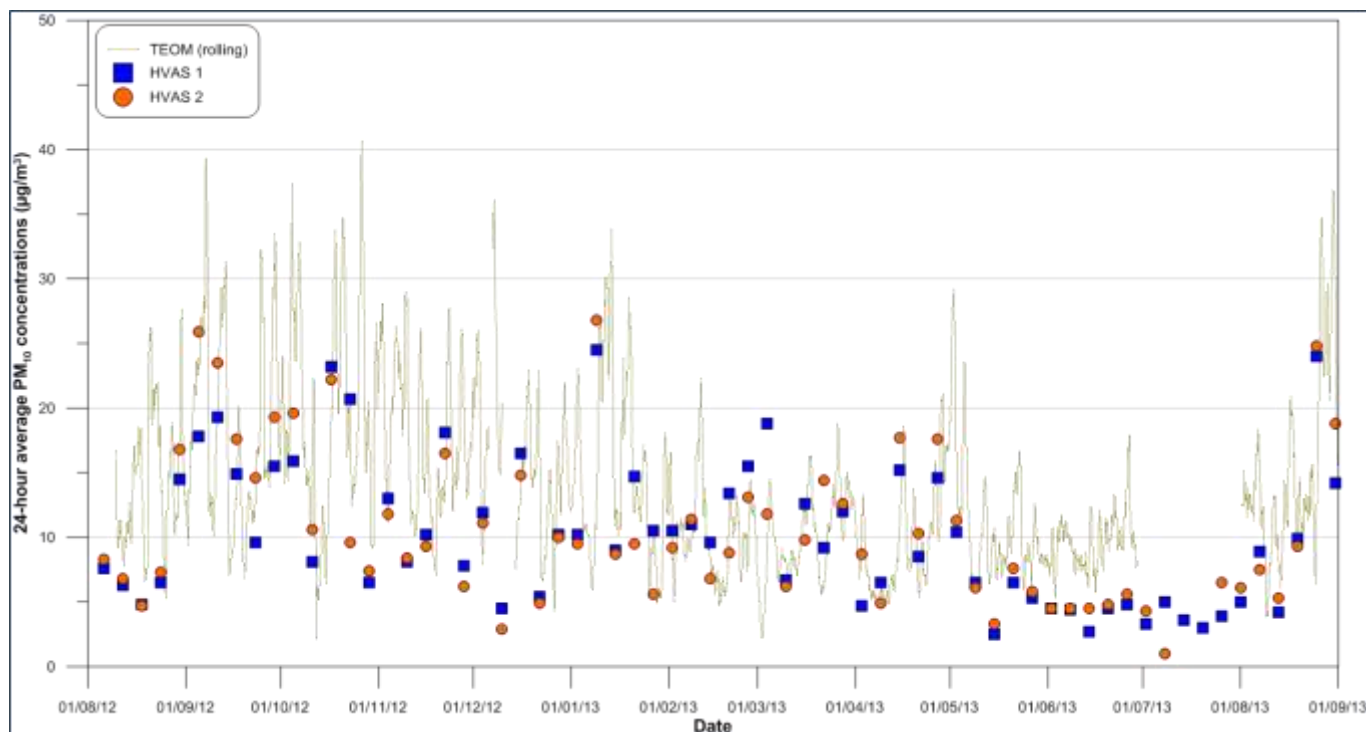
Figure 2: Stratford TEOM and HVAS 24-hour average PM₁₀ levels

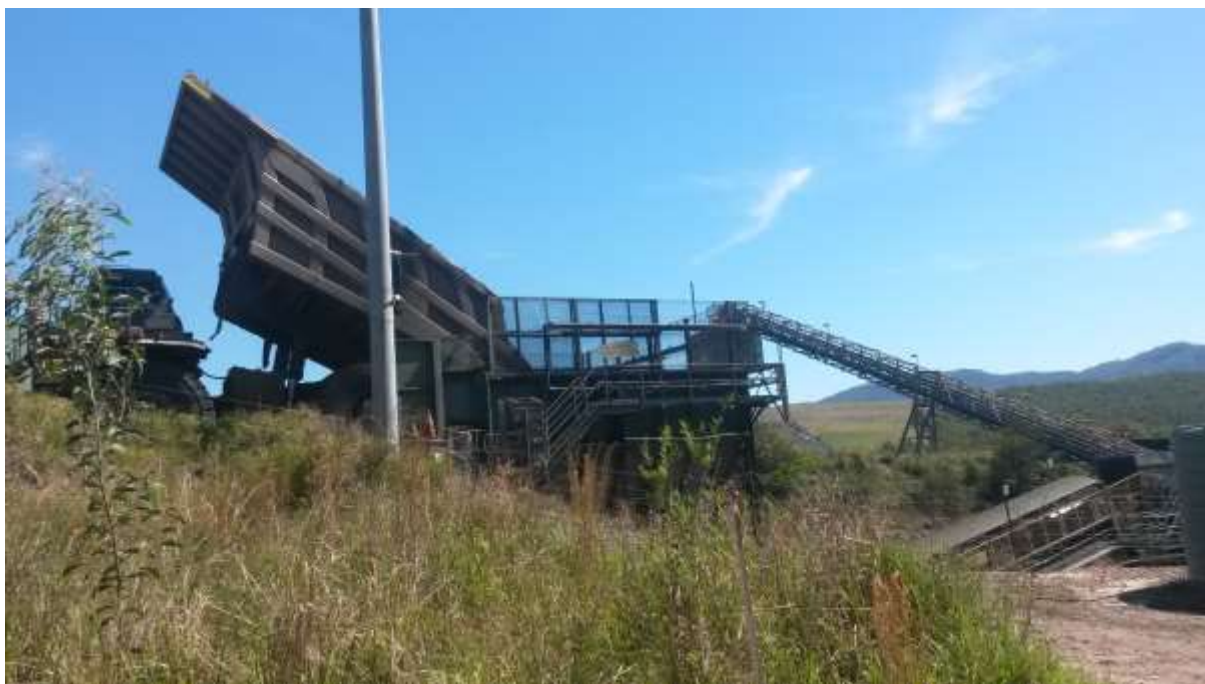
Figure 3 shows a haul truck unloading ROM coal into the hopper serving the rail load out bin. Whilst not obvious, coal can be seen tipping off the tray of the truck and into the hopper. There was no visible dust emission from any part of this activity. This is attributed to two things: the relatively moist nature of the ROM coal, and the use of water sprays on the inside of the hopper bin during coal unloading.

Figure 3: Loading ROM coal to hopper servicing rail load out bin

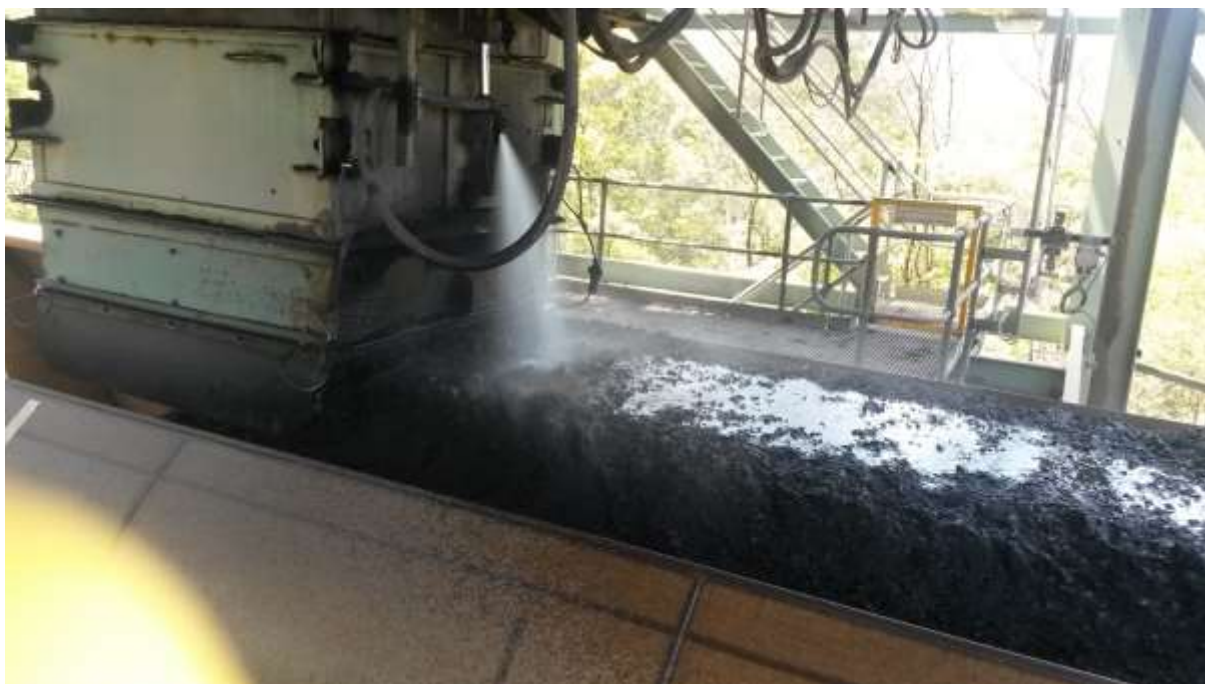
Figure 4 shows the operation of the coal load out chute and water sprays. It can be seen that the water sprays saturates the coal with extensive pooling of water evident on the coal surface.

The chute is positioned close to the height of the top of the coal wagons. This serves the purpose of “profiling” the coal surface to a smooth even level, and avoiding spillage of coal.

No dust was evident during the rail load out operation. This is attributed the moist nature of the ROM coal, and the use of water sprays on the surface of the coal being loaded into the wagons.

Figure 4: Loading of ROM coal into rail wagons at Duralie Coal Mine

It is recommended that the mine continues to operate the water sprays during loading of the coal wagons, upon departure of the coal train, during unloading of the coal train, and at hoppers and other points along the coal handling process.

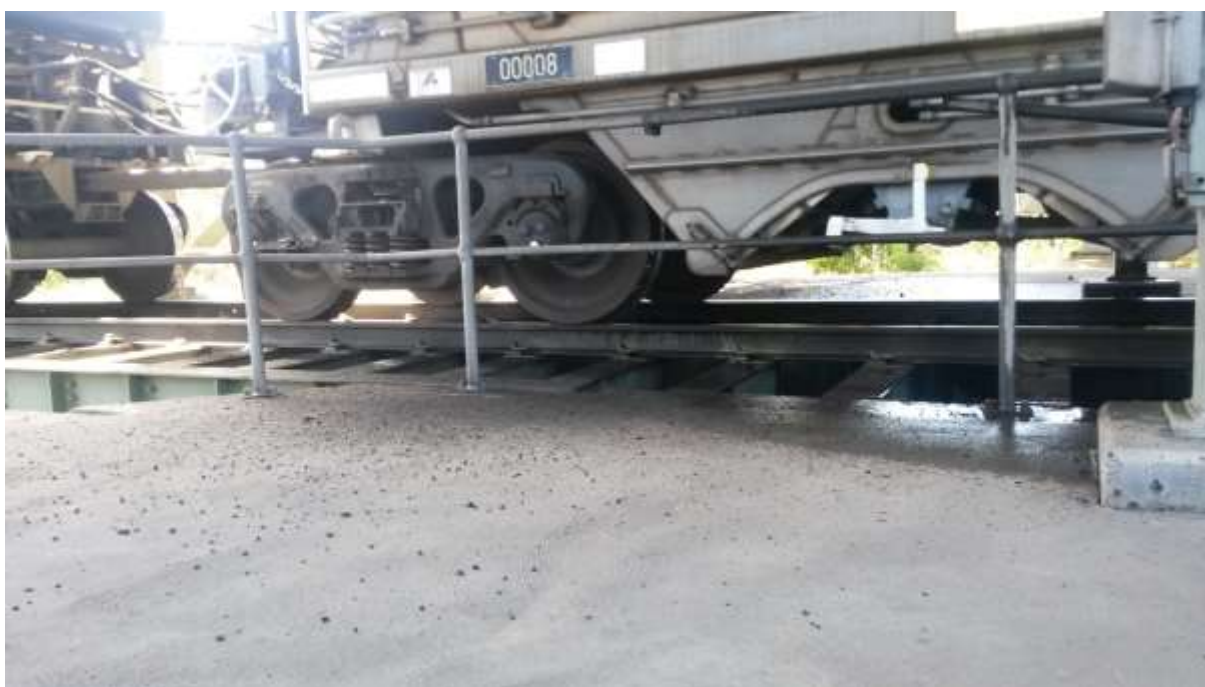
The effectiveness of the chute in controlling spillage is evident in the generally clean area under the rail load out bin, as shown in **Figure 5**.

Figure 5: Area under wagon load out at Duralie Coal Mine

In the event that excessive amounts of coal are found in the areas around the coal load out bin at Duralie Coal Mine and at the coal unloading terminal at Stratford Coal mine, the coal should be cleaned up promptly, and the site inspected shortly afterwards (a day or two later) in order to observe/ identify the cause of any excess coal spillage. Where a problem is found it should be promptly rectified.

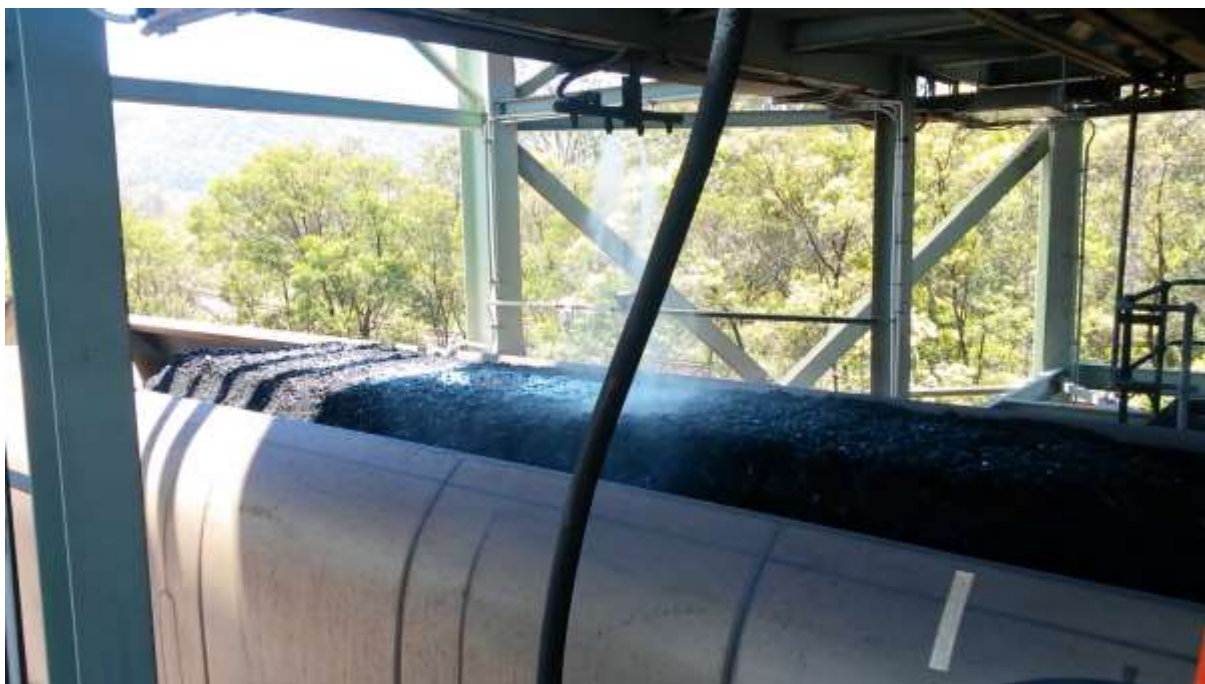
During the audit, the departure of the train was delayed due to a fault with one of the locomotives. This meant that the loaded train was stationary in the sun for a prolonged period prior to departure. The situation would carry more risk as the coal surface may dry out, and potentially release coal particles more easily.

It is normal practice to activate the bank of water spray nozzles to wet the coal surface for departing trains. This was done on this day, as shown in **Figure 6**, where the sprayed water can be seen pooling on the coal surface of the departing wagons.

Figure 6: Water spays on departing rail wagons at Duralie Coal Mine

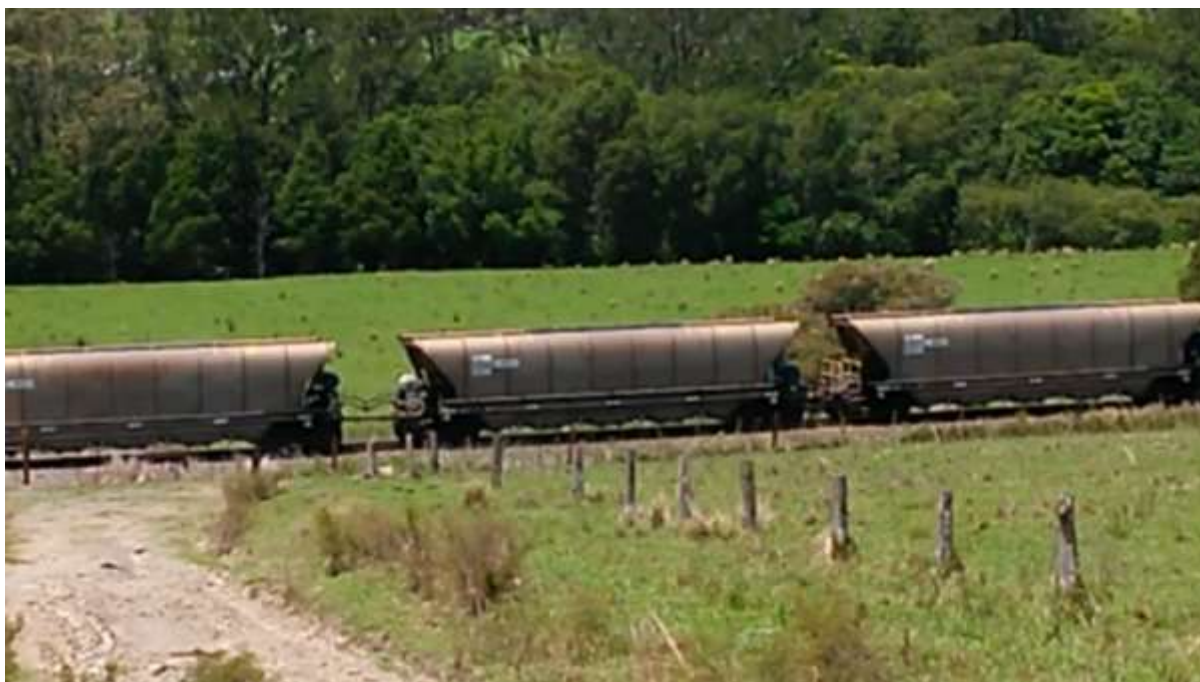
No dust was evident from the surface of the coal wagons or the rail line. The train was observed for some time prior to reaching the location, and after passing the location.

It is noteworthy, that due to the previously mentioned locomotive problem, some of the leading wagons were empty on this occasion. This would cause greater air turbulence over the moving train and mean that there was more scope for liberation of coal dust from the loaded wagons behind.

Figure 7 shows the last empty wagon (left) and the first full wagon (centre).

Figure 7: The loaded train at Martins Crossing Road crossing after departing from Duralie Coal Mine

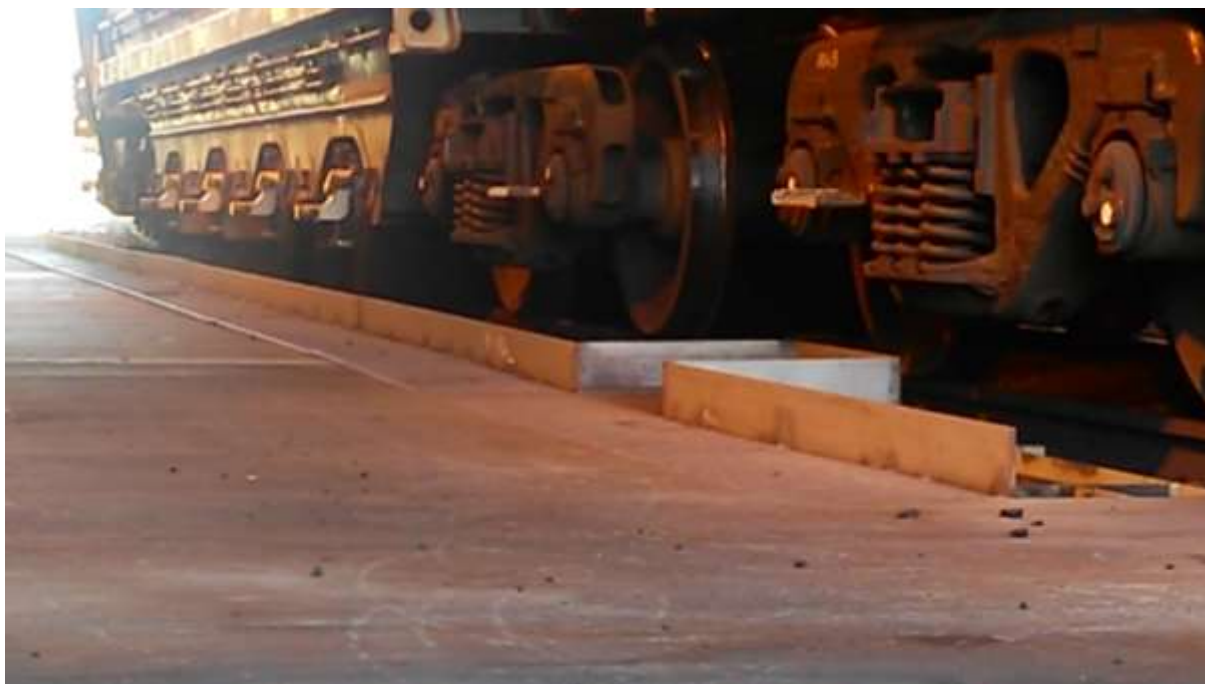
The same train was observed unloading coal at the Stratford Coal Mine rail loop. This is shown in **Figure 8**. The figure shows coal dropping from the bottom of the wagon, through the grate under the rail line and into the revivals hopper. The coal vigorously unloaded from the wagon in a short period, however no dust was noticeable during this operation. It is noted that a water spray operates during the unloading operation.

The system is automated to prevent excess discharge of coal, and this prevents spillage over the top of the receives hopper. A skirt is evident in the figure and serves the function of capturing coal that may bounce off the grate and rail line during unloading. These are relatively important dust controls, as rail bogies that plough through an overloaded hopper inevitably pick up coal which can later blow off or deposit on the rail line and become a source of dust.

Figure 8: Coal dropping from the bottom of the wagon into the rail unloading hopper (underneath the wagon)

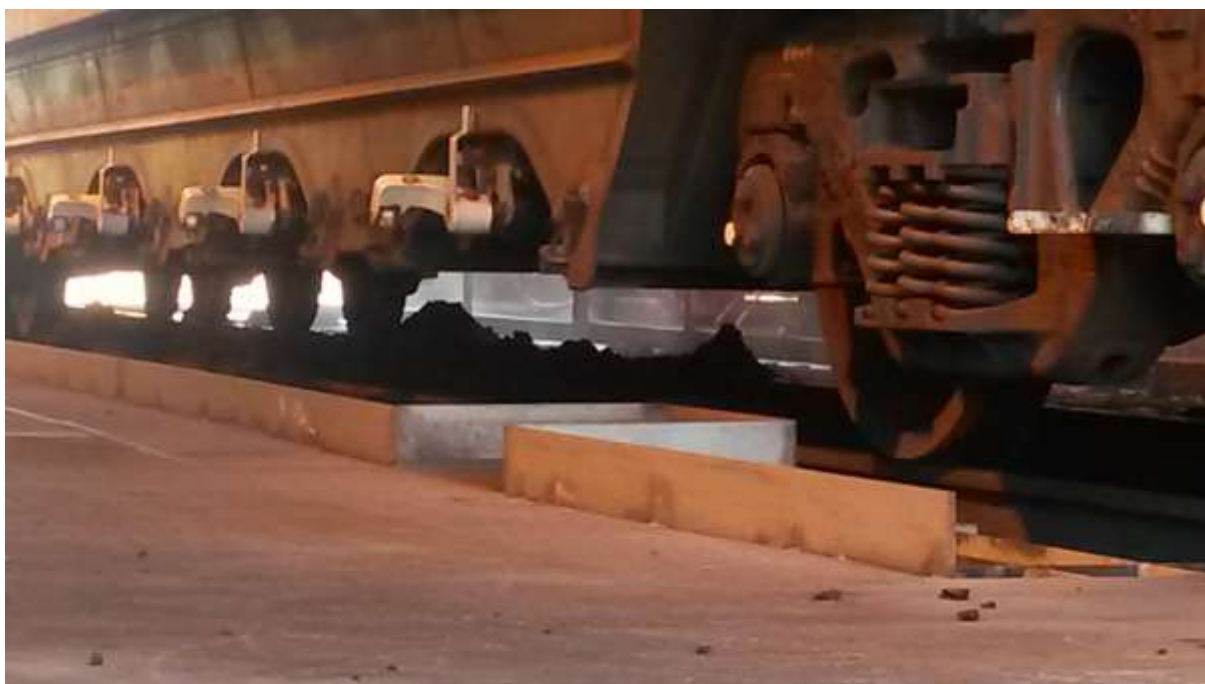
After unloading, the hatches at the bottom of the wagon are closed. **Figure 9** shows the closed hatches. The figure also shows the water spray that operates during the load out operation. The water spray is on the far side of the train to the photographer, but is seen as a mist in **Figure 9**.

Figure 9 and **Figure 10** show that coal does fall onto the rail line, and that the wheels of the wagons pass through this coal. The observations suggested that the coal does this because it is relatively wet. However the observations were that the coal sits on only a narrow part of the rail line and simply falls aside once a train's wheels begins to touch the coal.

Figure 9: Immediately after coal unloading, showing continuous water sprays (other side of wagon to photographer), and coal resting on the rail track.

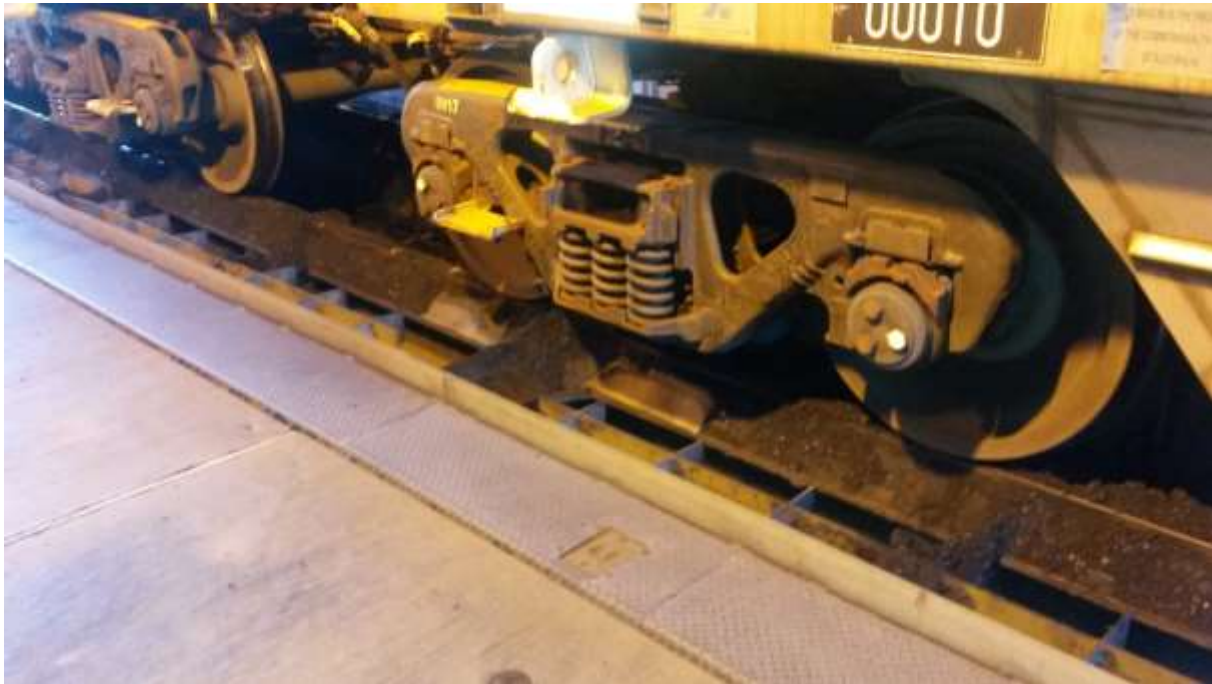
Figure 10: Same wagon just after unloading showing coal resting on rail track.

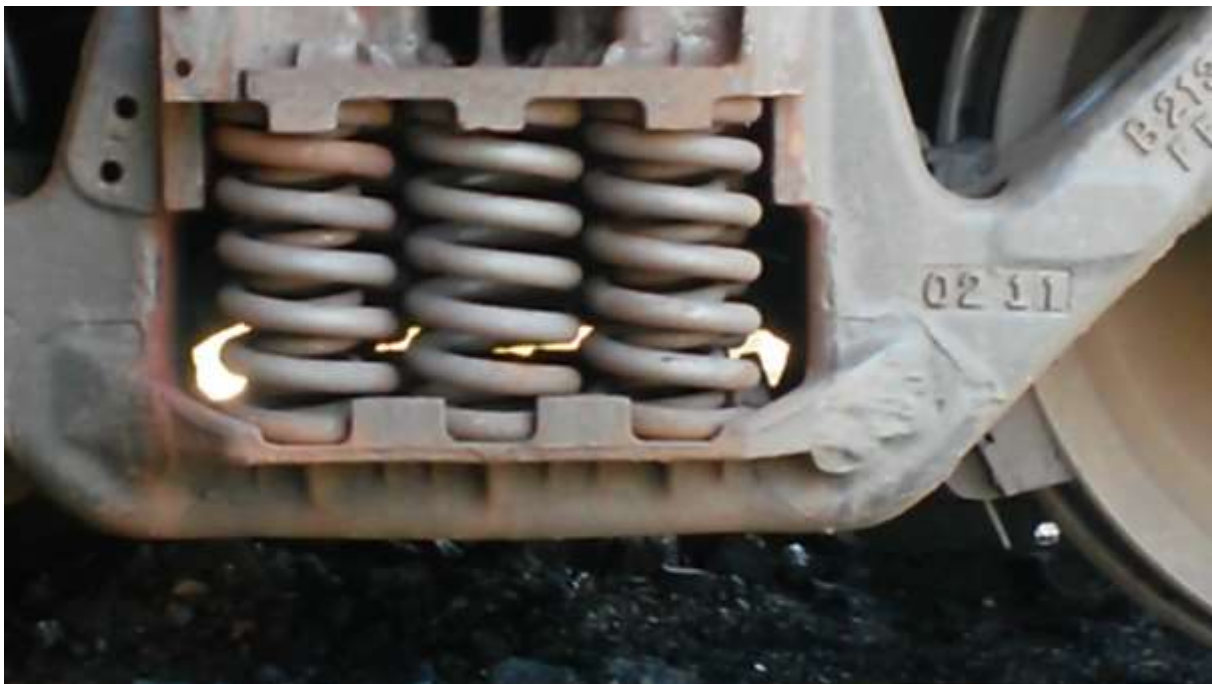
Figure 11 shows that after unloading, and pushing aside coal resting on the rail line surface, there was no parasitic coal evident on any parts of the wagon. This is important as it shows that the rail unloading operation works effectively to prevent coal carry over on the wagons, and avoids potential dust problems associated with coal coming off the wagons or depositing onto the tracks at a later time.

Figure 11: Same wagon after unloading and passing over coal resting on rail track, showing no evidence of parasitic coal attached to rail wagon bogies and undercarriage

Where excess parasitic coal is found on a number of wagons, the rail unloading operation should be observed to check for overfilling of the receiving hopper, and promptly rectified should a problem be found.

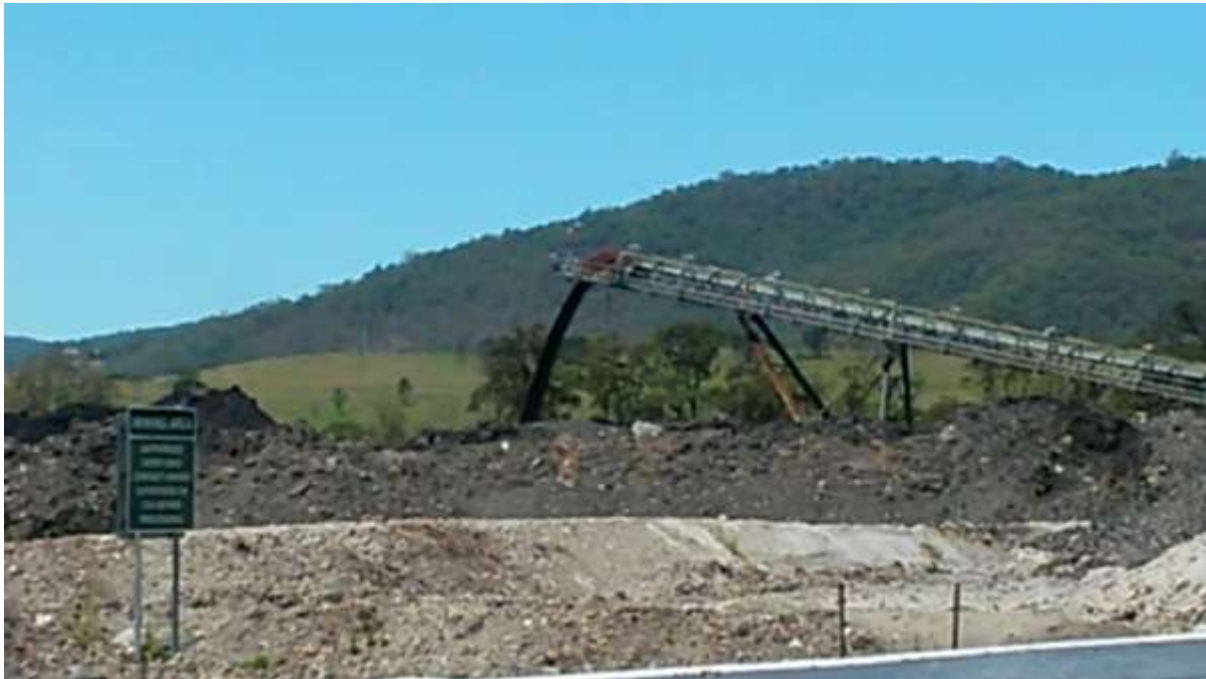
The operation of the conveyor and the fall of ROM coal onto the stockpiles is shown in **Figure 12**. No dust was observed during this operation.

Figure 12: Conveying and loading Duralie Coal Mine ROM coal to the Stratford Coal Mine stockpiles

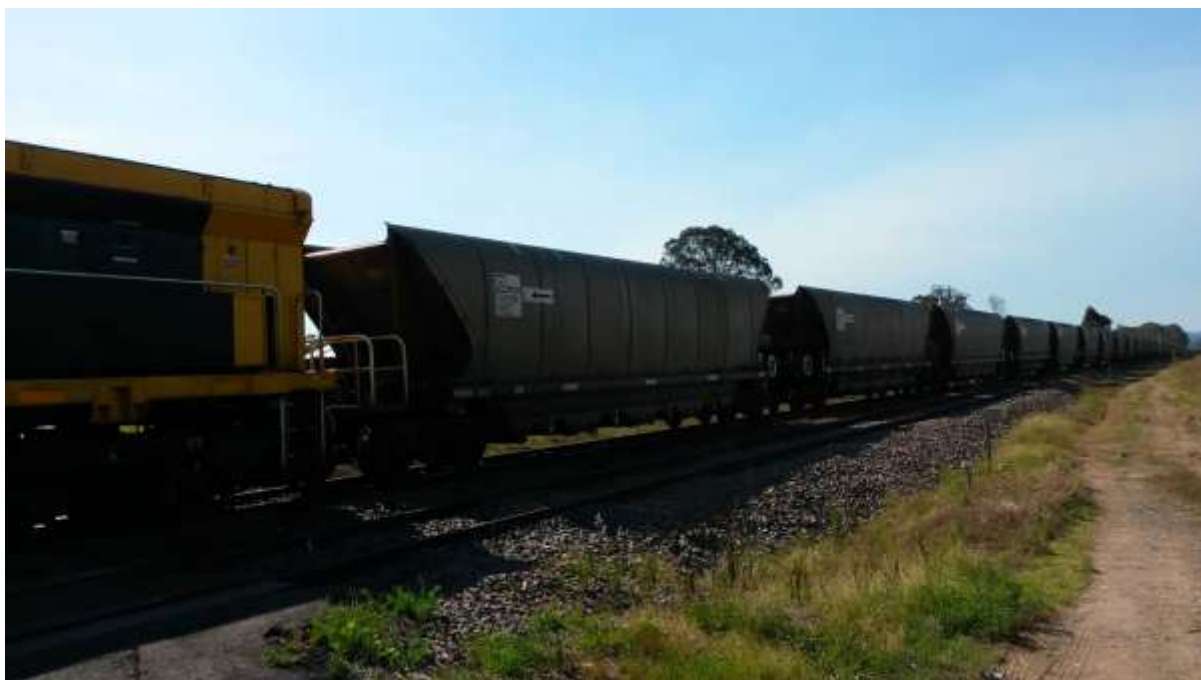
There was no visible dust evident from the unloaded wagons.

Figure 13: Empty coal wagon accelerating towards maximum speed

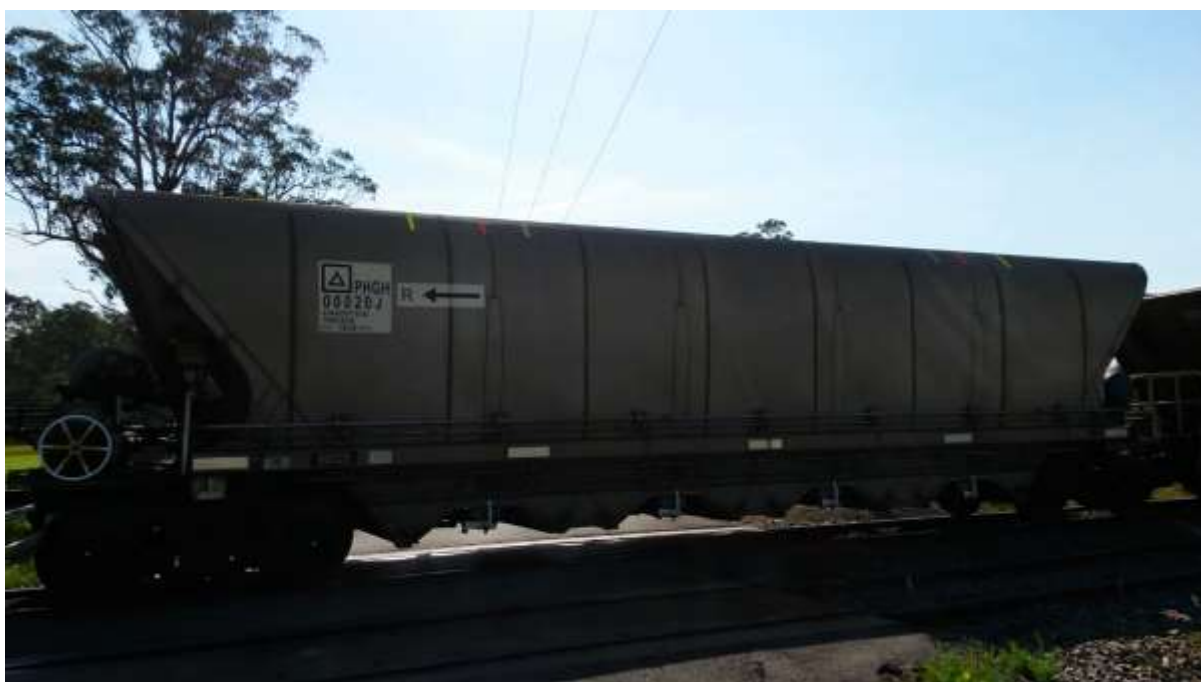
Figure 14: Close up of empty coal wagon nearing maximum speed

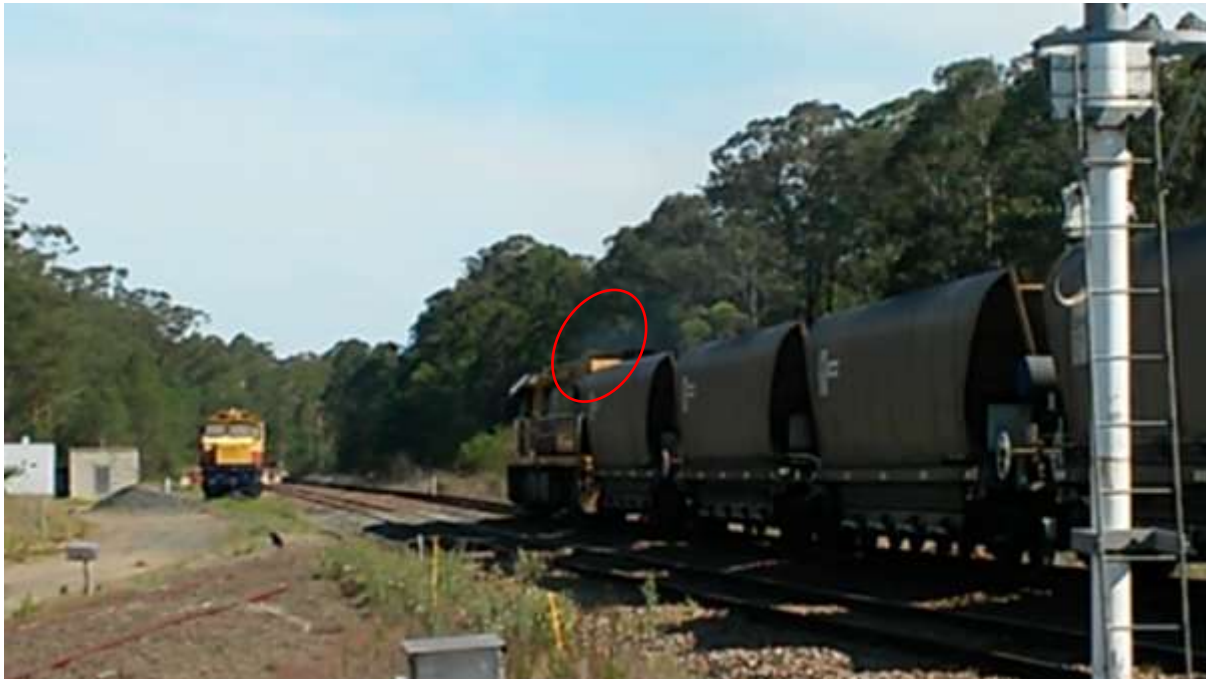
Smoke emissions from the diesel engine of the locomotive however were evident, and occurred under hard acceleration for a brief period of approximately 10 to 15 seconds. These emissions are not easy to see in the photograph, but have been circled in red in **Figure 15**.

It is noted that the locomotive diesel engine smoke emissions associated with the returning train were not unusual or remarkable relative to any other rail engines observed on the day, (i.e. XPT and goods trains).

Figure 15: Smoke from diesel locomotive under hard acceleration
