Duralie Coal CCC Meeting

Presentation – Company Report & Overview of Activities

August 2018

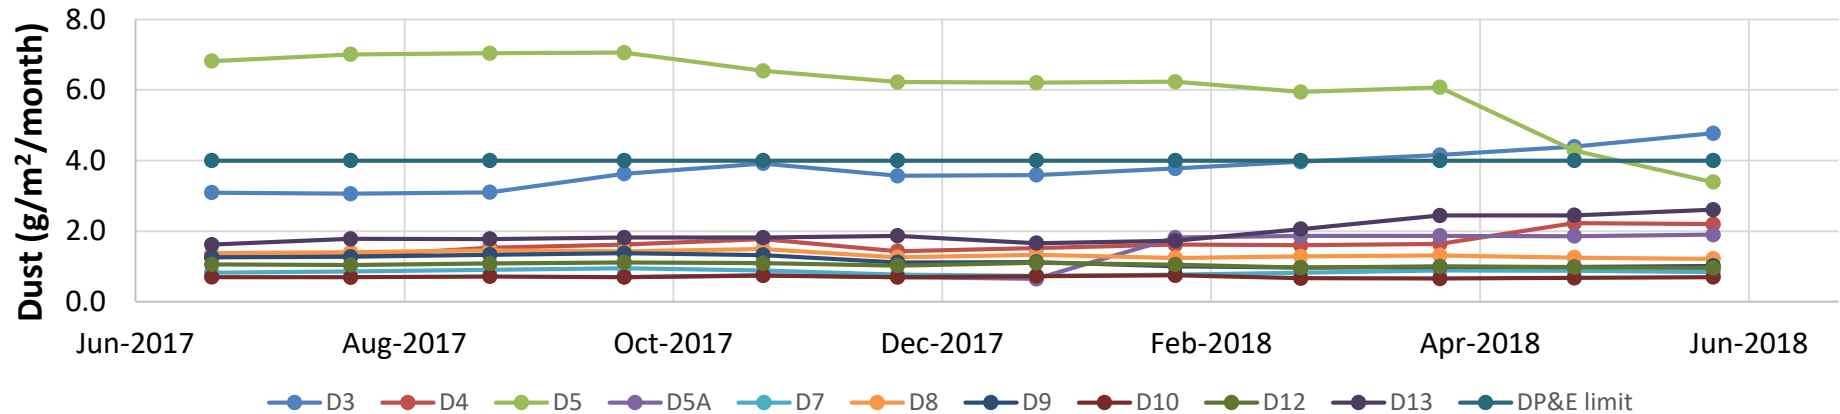
**Duralie Dust Deposition - Annual Rolling Average
12 Months to June 2018**

- Aug-17** D5 – 8.8 Very heavy - 30% dirt, 0% coal, 0% vegetation, 0% insects, 70% polysaccharide slime.
- Oct-17** D3 – 11.0 Very heavy - 30% dirt, 0% coal, 0% vegetation, 0% insects and 70% polysaccharide slime.
- Mar-18** D3 – 6.4 Very Heavy - 30% Dirt, 0% Coal, 0% Vegetation, 10% Insects, 60% Polysaccharide Slime. D13 – 5.2 Very Heavy - 30% Dirt, 0% Coal, 0% Vegetation, 0% Insects, 70% Polysaccharide Slime
- Apr-18** D13 – 4.9 Very Heavy - 50% Dirt, 0% Coal, 0% Vegetation, 0% Insects, 50% Polysaccharide Slime
- May-18** D3- 4.3 Heavy - 40% Dirt, 0% Coal, 0% Vegetation, 0% Insects, 60% Polysaccharide Slime. D4- 10.6 Very Heavy - 10% Dirt, 0% Coal, 0% Vegetation, 0% Insects, 90% Polysaccharide Slime
- Jun-18** D3 – 9.5 Very Heavy - 10% Dirt, 90% Polysaccharide Slime. D13 – 4.4 Very Heavy - 40% Dirt, 60% Polysaccharide Slime

- High levels in D3 and D5 due to contamination of multiple samples. Additional site D5A installed for comparison.
- Due to frequent contamination of dust gauges the HVAS results should also be used when interpreting results.

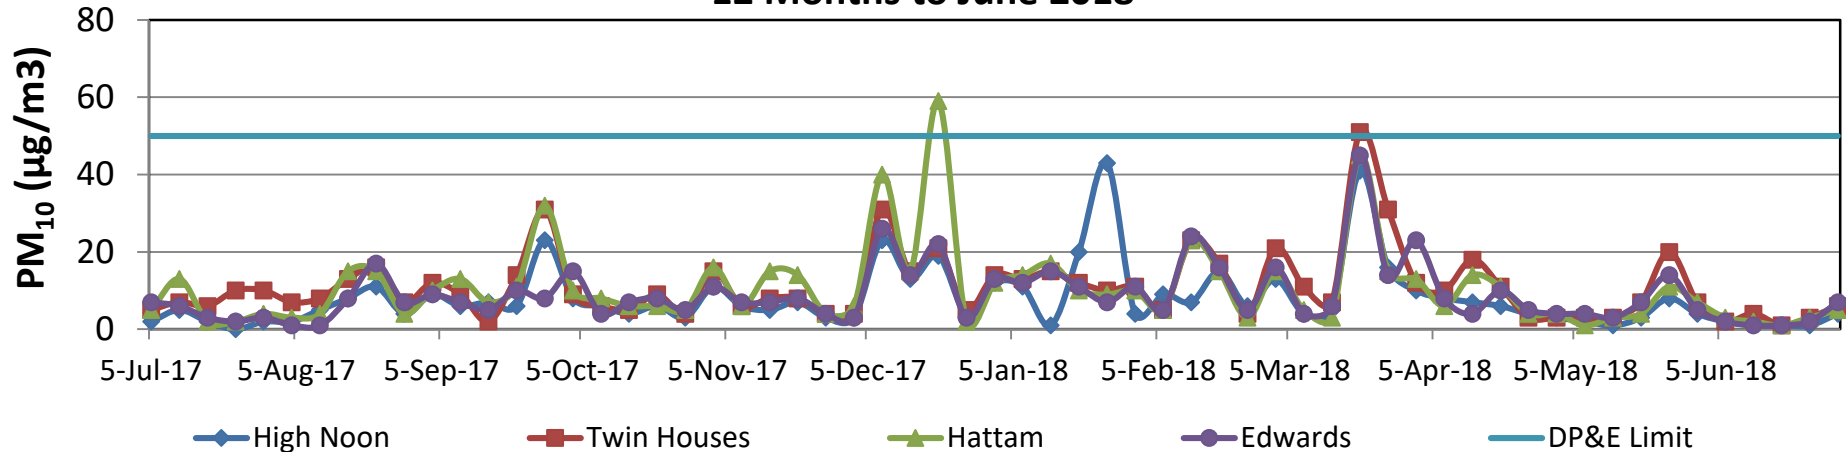
**Duralie HVAS Monitoring (PM₁₀)
12 Months to June 2018**

- All sites below DP&E limit. Typically low results during winter and higher during spring/ summer.
- Elevated results recorded at Hattam during December 2017 due to bushfire smoke.
- High results across all monitors on 20-Mar-18 due to hazy conditions across valley following a southerly change and prolonged dry weather.
- Flat trend over previous 12 months.
- HVAS results provide more reliable data compared to dust deposition results and should be referred to when interpreting dust emissions.

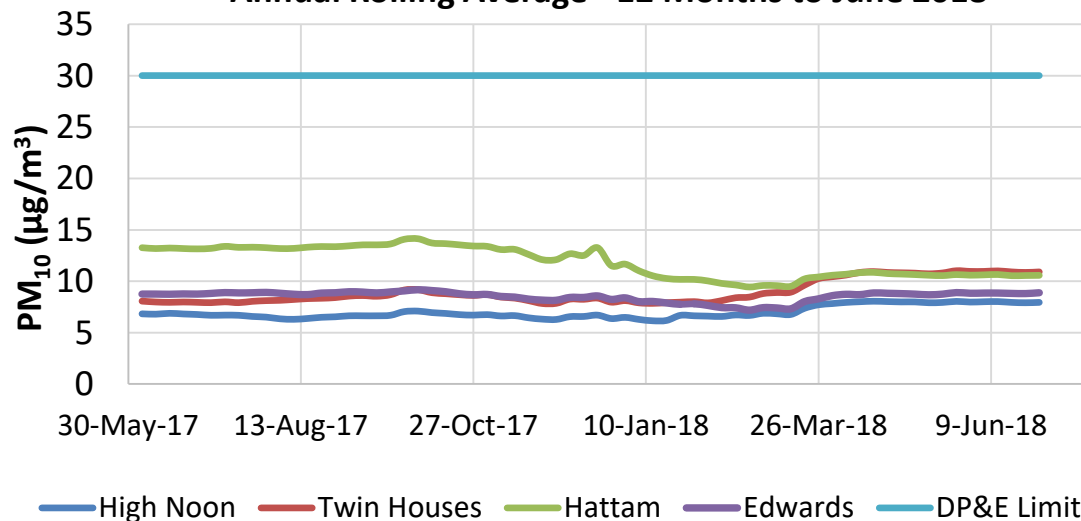
**Duralie HVAS Monitoring (PM₁₀)
Annual Rolling Average - 12 Months to June 2018**

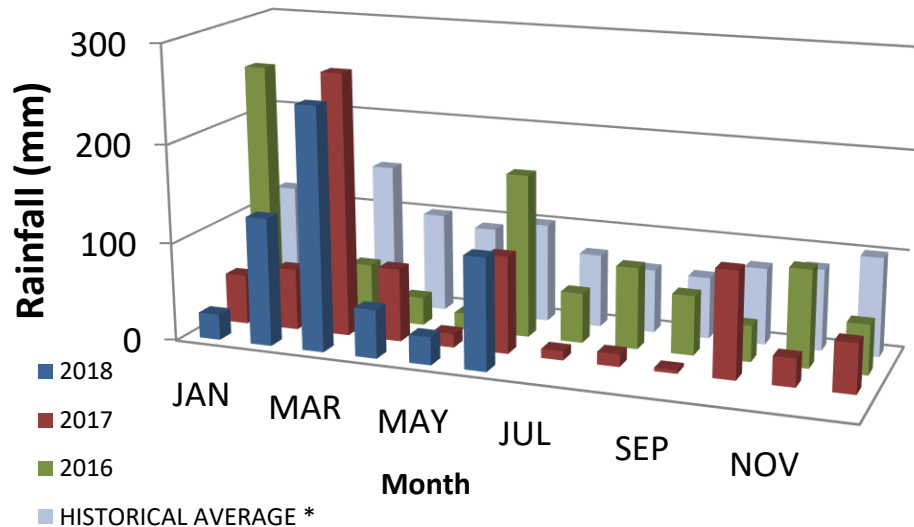
Duralie Mine Site - Monthly Rainfall

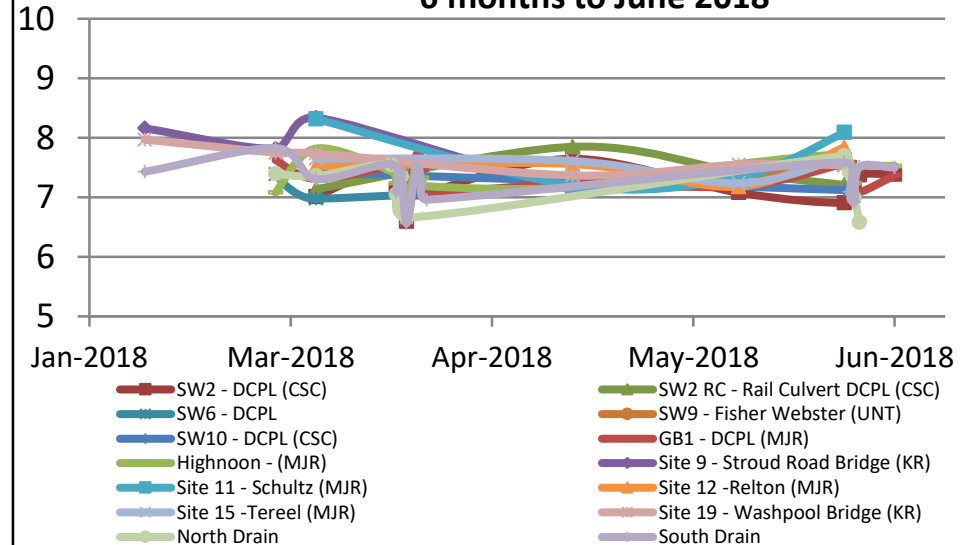
**Duralie Surface Water Monitoring - pH
6 months to June 2018**

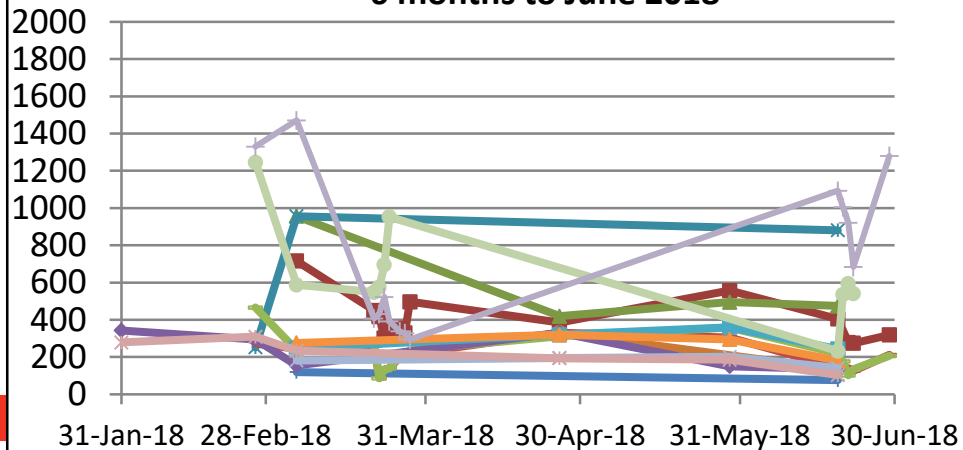
**Duralie Surface Water Monitoring - EC ($\mu\text{S}/\text{cm}$)
6 months to June 2018**

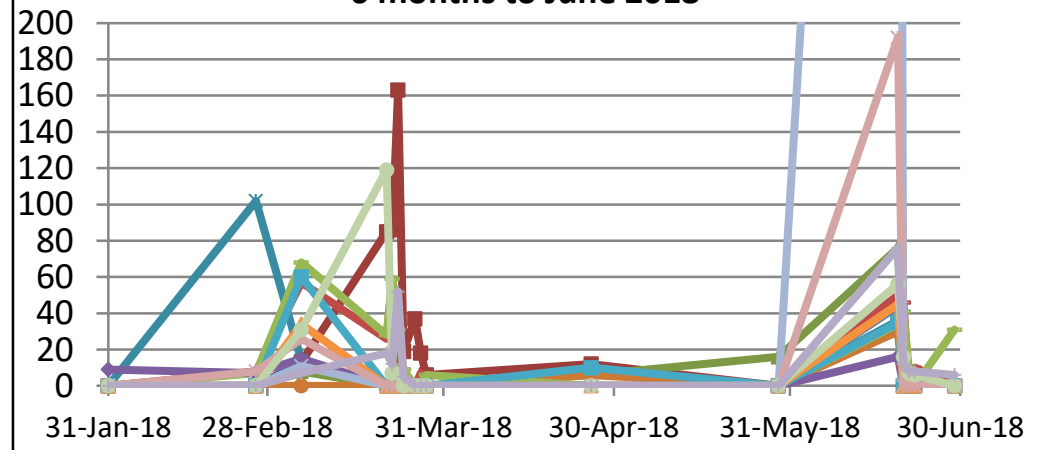
**Duralie Surface Water Monitoring - TSS (mg/L)
6 months to June 2018**

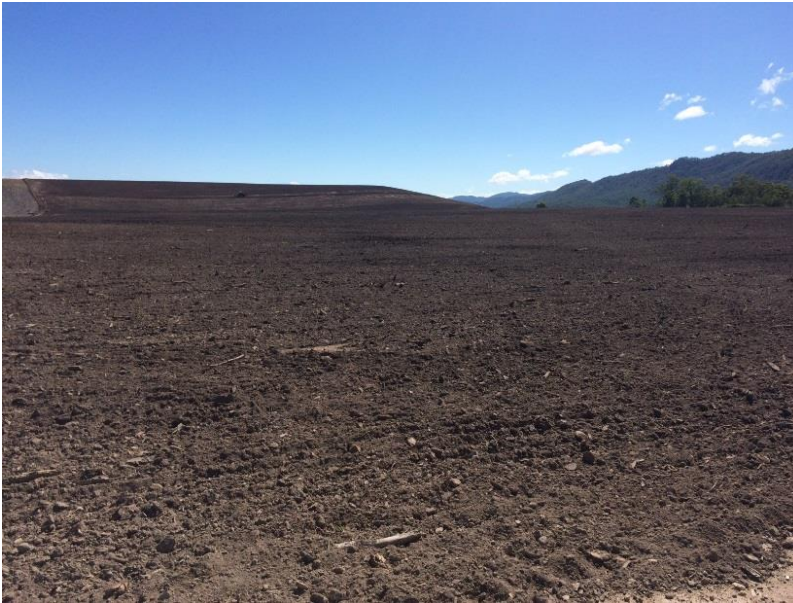
Photo: Completed rehabilitation on the Weismantel waste emplacement Apr 2018.

Management Area	Project	Status
Rehabilitated Waste emplacements	<ul style="list-style-type: none">• Final landforms designs• Bulk Shaping• Rehabilitation Works	<ul style="list-style-type: none">• Final landform designs have been progressed for the waste emplacement areas in Clareval and Weismantel.• A D11 Dozer has continued bulk shaping works on the Weismantel waste emplacement. Approximately 60ha completed.• Rehabilitation of 30-40ha is planned to be completed in October 2018, including topsoil spreading, ground preparation and seeding.

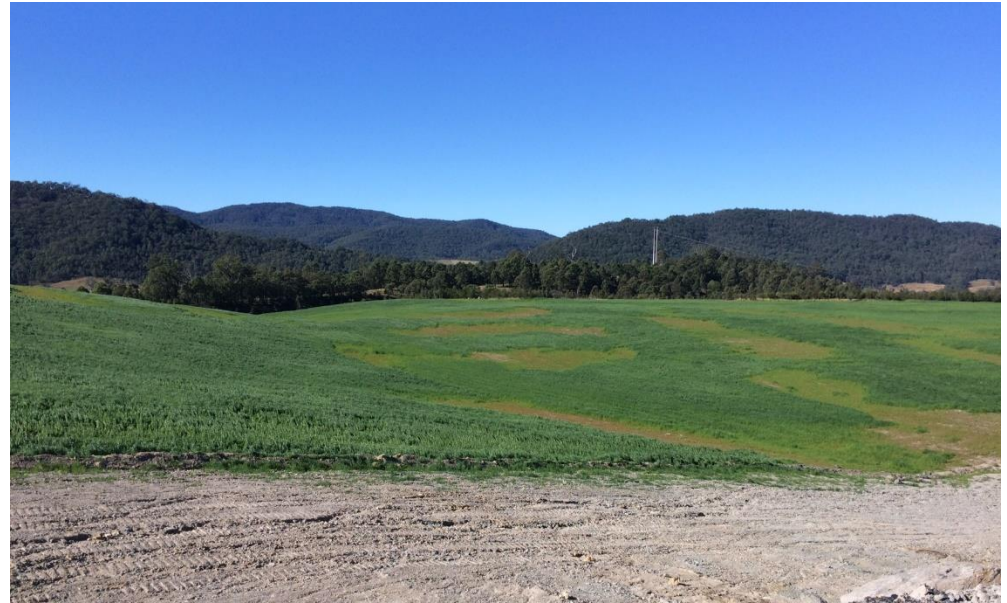
Photo: Rehabilitation progress July 2018.
